NRL MEMORANDUM REPORT No. 192

FINAL REPORT ON ENGINEERING EVALUATION OF SCANNING SONAR EQUIPMENT MODEL QHD SERIAL NO. 1

H. H. Elliott, Jr. SOUND DIVISION

20 July 1953

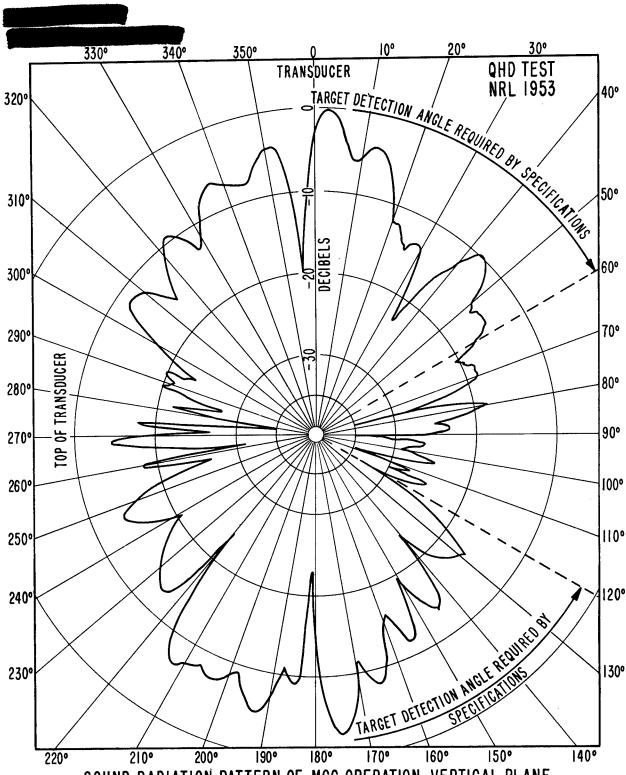
SOUND RADIATION PATTERN OF MCC OPERATION, VERTICAL PLANE TRANSDUCER WIRES TO MCC SECTION REVERSED TERMINALS 49 TO 50 AND 50 TO 49 ON BOARD E 1905

- e. When the transducer was operated under MCC conditions (with connections as shown in wiring diagram), the transmitted beam was deflected upward instead of downward. See Figure 21. The MCC transmitted beam was deflected downward when these leads were reversed. See Figure 22.

- 17. The electrical phase angles of the transducer staves should be made to be within ± 3 degrees of the mean.
- 18. The sound radiation pattern of the transducer should be improved at the larger depression angles when operating under MCC conditions, and the nullification of the beam in the horizontal plane should be improved.

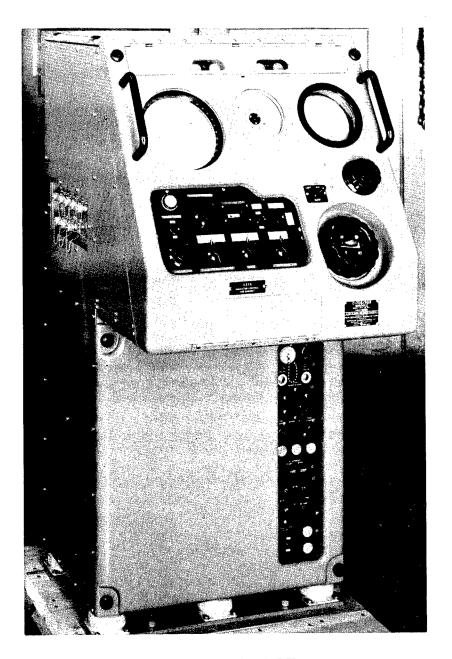
CONSOLE ASSEMBLY TYPE C-706/SQS

- 1. Console Assembly C-706/SQS:
 - a. Six standoff insulators for high voltage leads in power supply were loose.
 - b. Threads were stripped on hold-down bolts for top cover of high-voltage power supply chassis.
 - c. Threaded portion of spade lugs of condenser holding clamps in numerous cases were too long. Examples: C-2708, C-2753, C-2754, and C-2755.
 - d. Readability of function designation markings on mounting board containing the PPI gating, range mark, spiral balance controls, etc., was very poor. Ink color too nearly matched color of the mounting board.

- f. Symbol designations were missing for C-2317, G-2101, R-2103, R-2333, R-2334, R-2335, R-2465, R-2467, S-2110, S-2113, S-2704, V-2304, and TP-2304.
- g. Circuit diagram showing working voltage, current rating, etc., was missing on L-2701.

- o. Lower right front hinged control panel was not provided with a catch for holding panel in the maintenance position.
- p. Cardboard and paper frame of dust filter was flammable and moisture absorbent, and would support fungus growth.

- r. The holding screws of the timing unit back cover plate were poorly positioned. Upper screw could short R-2853, R-2854, and R-2855 to ground. Second screw could damage R-2876. Third screw could ground R-2741. Fourth screw could damage R-2755.

- 3. Supports for receiver chassis cover plates should be repositioned in order that cover plate screws may more easily be removed and reinserted and to prevent damage to panel gasket when removing screws.

- 4. Screws, bolts, etc., should be so positioned as to eliminate hazard of shorting to ground or damaging electronic components.
- 5. Locking devices should be provided for holding console hinged panel (lower right control panel) in the maintenance position. (Ref. (j), par. D-2a(3).)

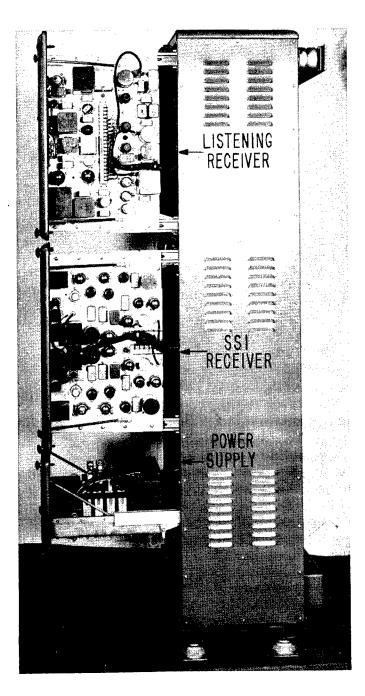
RECEIVER ASSEMBLY TYPE R-354/SQS RIGHT SIDE VIEW

- a. Front brackets, for receiver chassis cover plate securing screws, were too close to the front panel. Screws were not easily removed and front panel rubber gasket could have been damaged when the screws were removed.
- b. Power supply chassis was mounted on rollers and slides and no provisions were made for tilting of chassis to facilitate servicing. Bottom of chassis was approximately 12 inches above the deck, making access to terminal connections of component parts extremely difficult.
- c. Terminal designation markings of conductor sleeving were blurred and practically unreadable.

- h. Type or symbol designation marking was missing for C-3328, R-3348, R-3708, and V-3113.
- i. Markings showing circuit diagram, rating, working voltage, current, etc., were missing on T-3106 and T-3802.

- j. Circuit diagram, rating, etc. of T-3302 were obscured by T-3303. T-3303 was so positioned that it's circuit diagram marking could not be read.
- k. One swaging tool was found in wiring of test set.

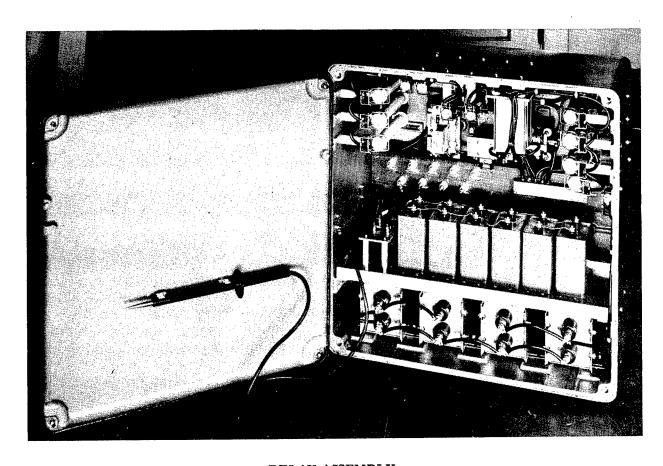
RELAY ASSEMBLY TYPE RE-84/SQS OPEN VIEW

- 10. Relay Assembly RE-84/SQS
 - a. Terminal connection was loose on C-501 and on the -3400-volt terminal board.
 - b. Support for C-513 was loose.
 - c. Terminal board E-502 was not symbol designated and had less than the required number of spare terminals.
 - d. Unit was not shock mounted.
 - e. Very slight amount of oil seepage from the bottom of C-503 and C-504 appeared hot to have affected the capacitors electrically.
- 11. Receiver-Storage Scanner R-522/SQS
 - a. Mounting bolts of transformers and filter units and spade lugs of capacitor holding clamps were too long. (Applies to 49 storage amplifier units.)
 - b. Spade lug of holding clamp for C-4201 was too long.
 - c. Plate cap of V-4210 struck the bottom of the amplifier chassis when the power supply tube chassis was tilted forward to the maintenance position.

- d. Spare terminals were not provided on terminal boards E-4105, E-4106, E-4107, and E-4108.
- e. Cardboard and paper frame of dust filters were flammable, moisture absorbent, and would support fungus growth.
- f. Scan Gain potentiometer was incorrectly designated as R-4316 on rear of chassis.
- g. Capacitor C-4409 is not JAN type.
- h. Resistors R-4247, R-4248, R-4309, R-4311, R-4316 and R-4411 were not JAN type.
- i. 110-volt ac utility outlet was not provided.
- j. Sound power phone outlet was not provided.
- k. Lifting bolt holes were at each top corner of the assembly but lifting bolts were not furnished. The tapped holes were not properly labeled, "Lift Here".
- 12. Loudspeaker LS-168/U (4 units)

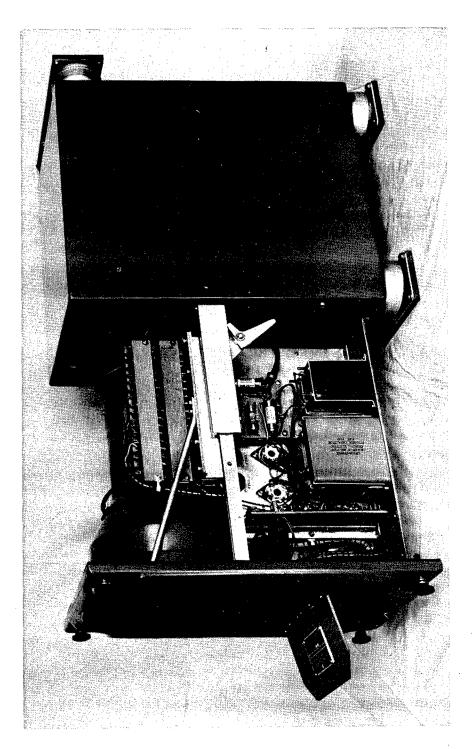
AZIMUTH RANGE INDICATOR TYPE IP-95/SQS (REMOTE PPI) SIDE VIEW

- 13. Azimuth Range Indicator (PPI) IP-95/SQS (3 units)
 - a. Depth was 1/2 inch over the allowable limit of 17-1/2 inches.
 - b. Some leads were excessively long and were unsecured. Examples: Pin 2 of X-204 to C-201, from C-201 to L-201, from R-203 to pin 2 of X-204, and from L-201 to X-204.
 - c. No circuit diagram, voltage rating, current rating, etc., were marked on T-201 and I-201.
 - d. Serial No. 1 CRT was out of its socket and tube shield was bent.
 - e. Serial Nos. 1 and 3, front cover plates for CRT were cracked at lower mounting screw hole.
 - f. Sound power telephone receptacle was unmarked on all three units.
 - g. Resistor R-284 (50 megohms) was not a JAN value.
 - h. Capacitors C-288 and C-289 were not JAN values.
 - i. Terminal board E-201 had less than the required 20 percent spare terminals
